# STAINLESS STEEL

## Whirl-A-Way Rotary Head Breakdown

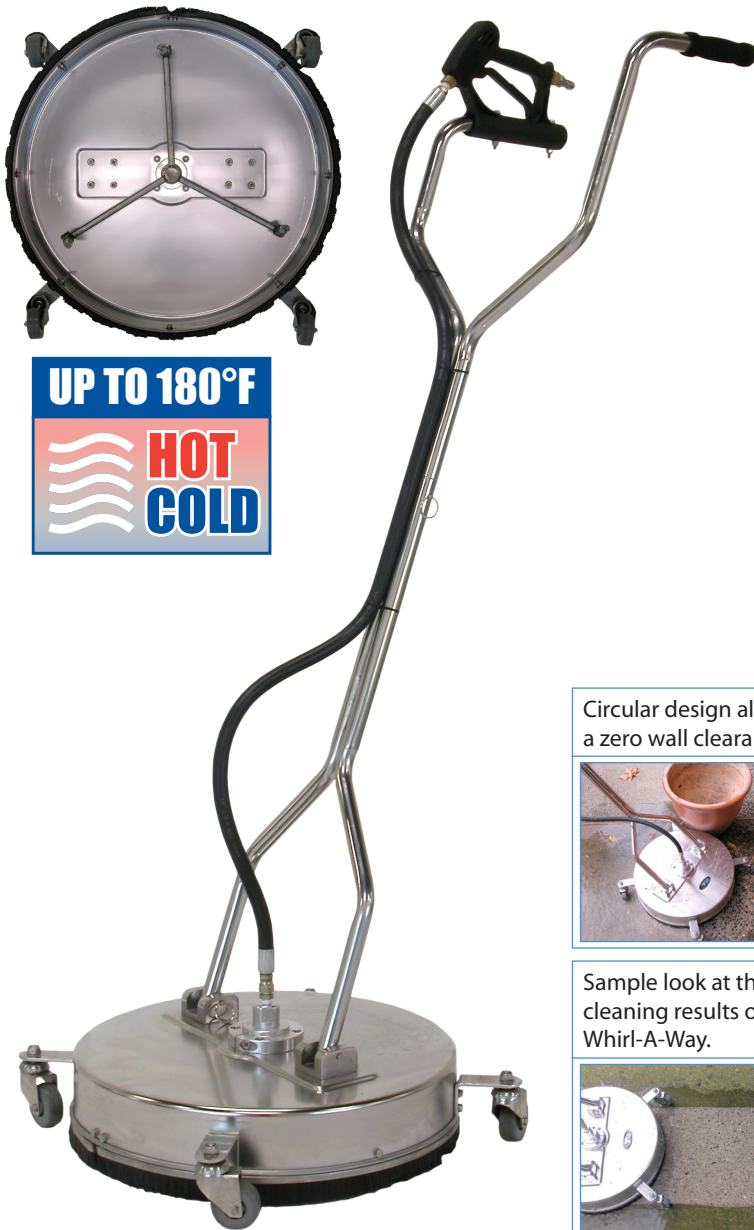
Circular design allows a zero wall clearance.

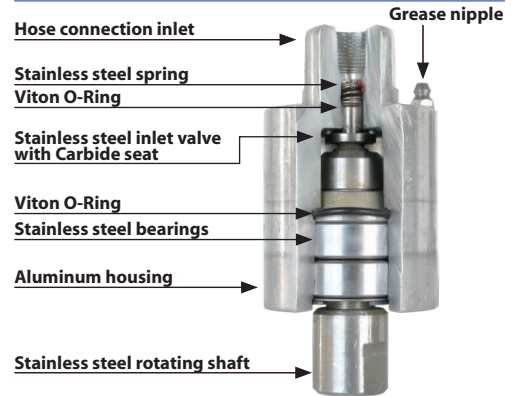
Part#	Replacement Part
85.790.004	Rotary Head
85.791.010S	Tri-Rotary Arm 11"R
85.790.020	1.5" Non Marking Caster
85.790.019S	Nylon Brush Skirt
85.790.010	Rotary Head Repair Kit
85.225.020	Replacement Nozzle Tip
85.202.115	Replacement Spray Gun

- 1 Non Marking Casters
- 2 Stainless Steel Bearings
- 3 4,000 PSI Rotary Head, 160°F
- 4 Welded Stainless Steel Rotary Arm

- 5 Welded Elbows and Assembly
- 6 Field Repairable Gun
  - Water Flow Out Front Prevents Cavitation
  - Zero Wall Clearance

Part#	Replacement Part
85.790.004	Rotary Head
85.791.012	Tri-Rotary Arm
85.790.009	1" Non Marking Caster
85.790.014S	Nylon Brush Skirt
85.790.010	Rotary Head Repair Kit
85.225.020	Replacement Nozzle Tip
85.202.115	Replacement Spray Gun
